Important message from TELSTRA - potential risk of damage when marking routes using in ground marker posts.

(This message is being sent to all Telstra Accredited Plant Locator companies).

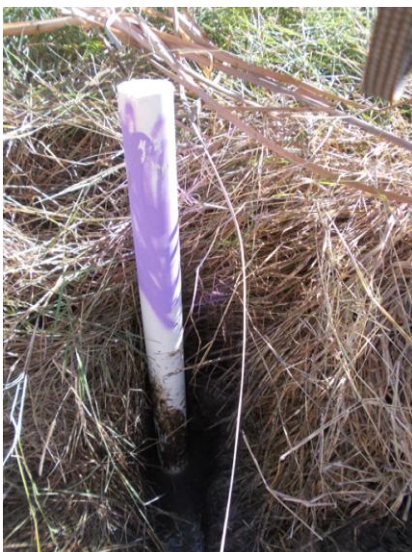
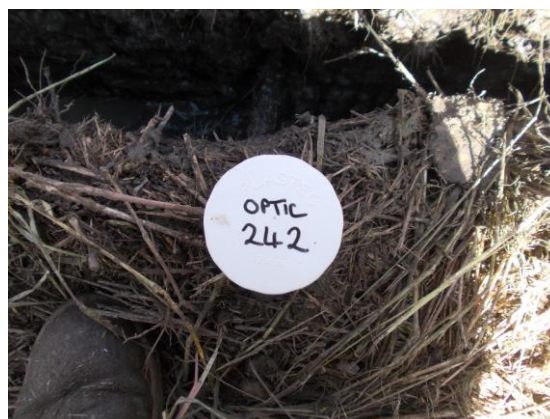
Recently an interstate Telstra fibre cable (core network) was cut due to a temporary marker post (pvc conduit) placed directly onto the cable to mark the route.
A vehicle accidentally coming into contact with the marker pushed down onto the cable severing it.

All in ground route markers should not be placed directly on top or against cables in a way where if pushed down or sideways they will cause damage.
